# CHARTS FOR ANALYSIS OF MC20 POLLUTION OBSERVATIONS 2011—2015

2015 April 26

Bonny L. Schumaker  
On Wings Of Care, Inc.

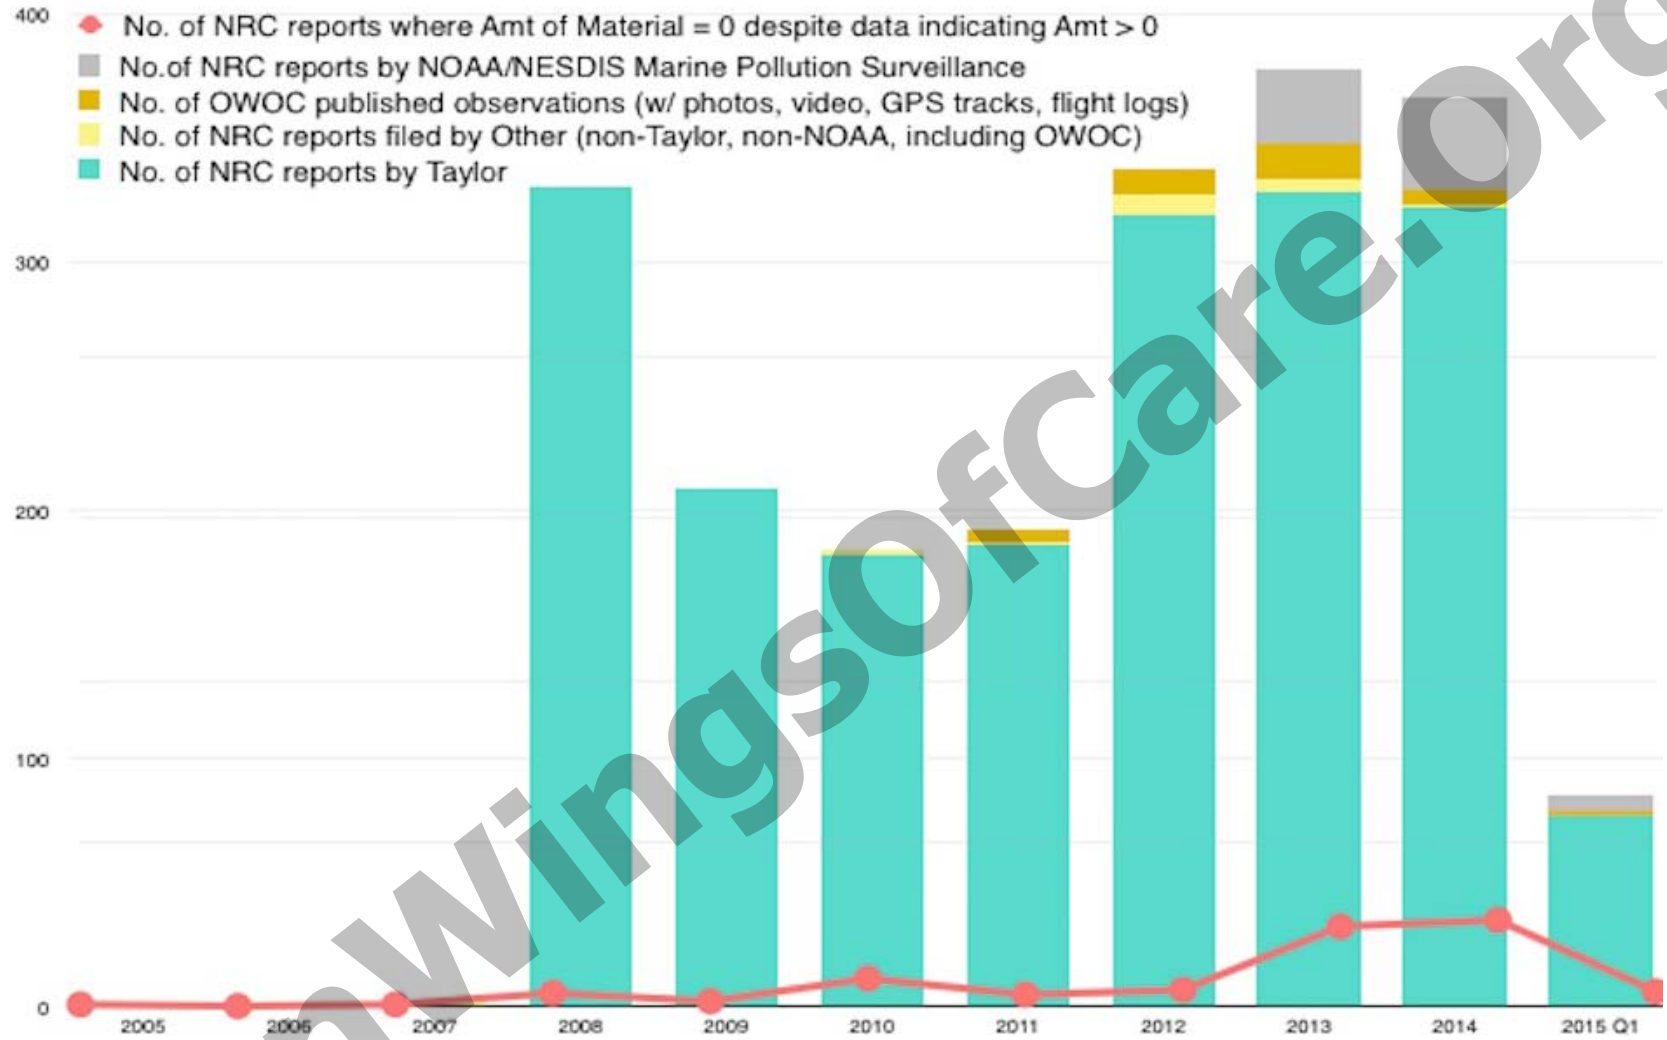
### Number and Sources of Reports on Pollution in MC20: 200402015Q1

Figure 1. Sources of NRC reports and other observations since 2005, and their total numbers each year.

Figure 1. Sources of NRC reports and other observations since 2005, and their total numbers each year.

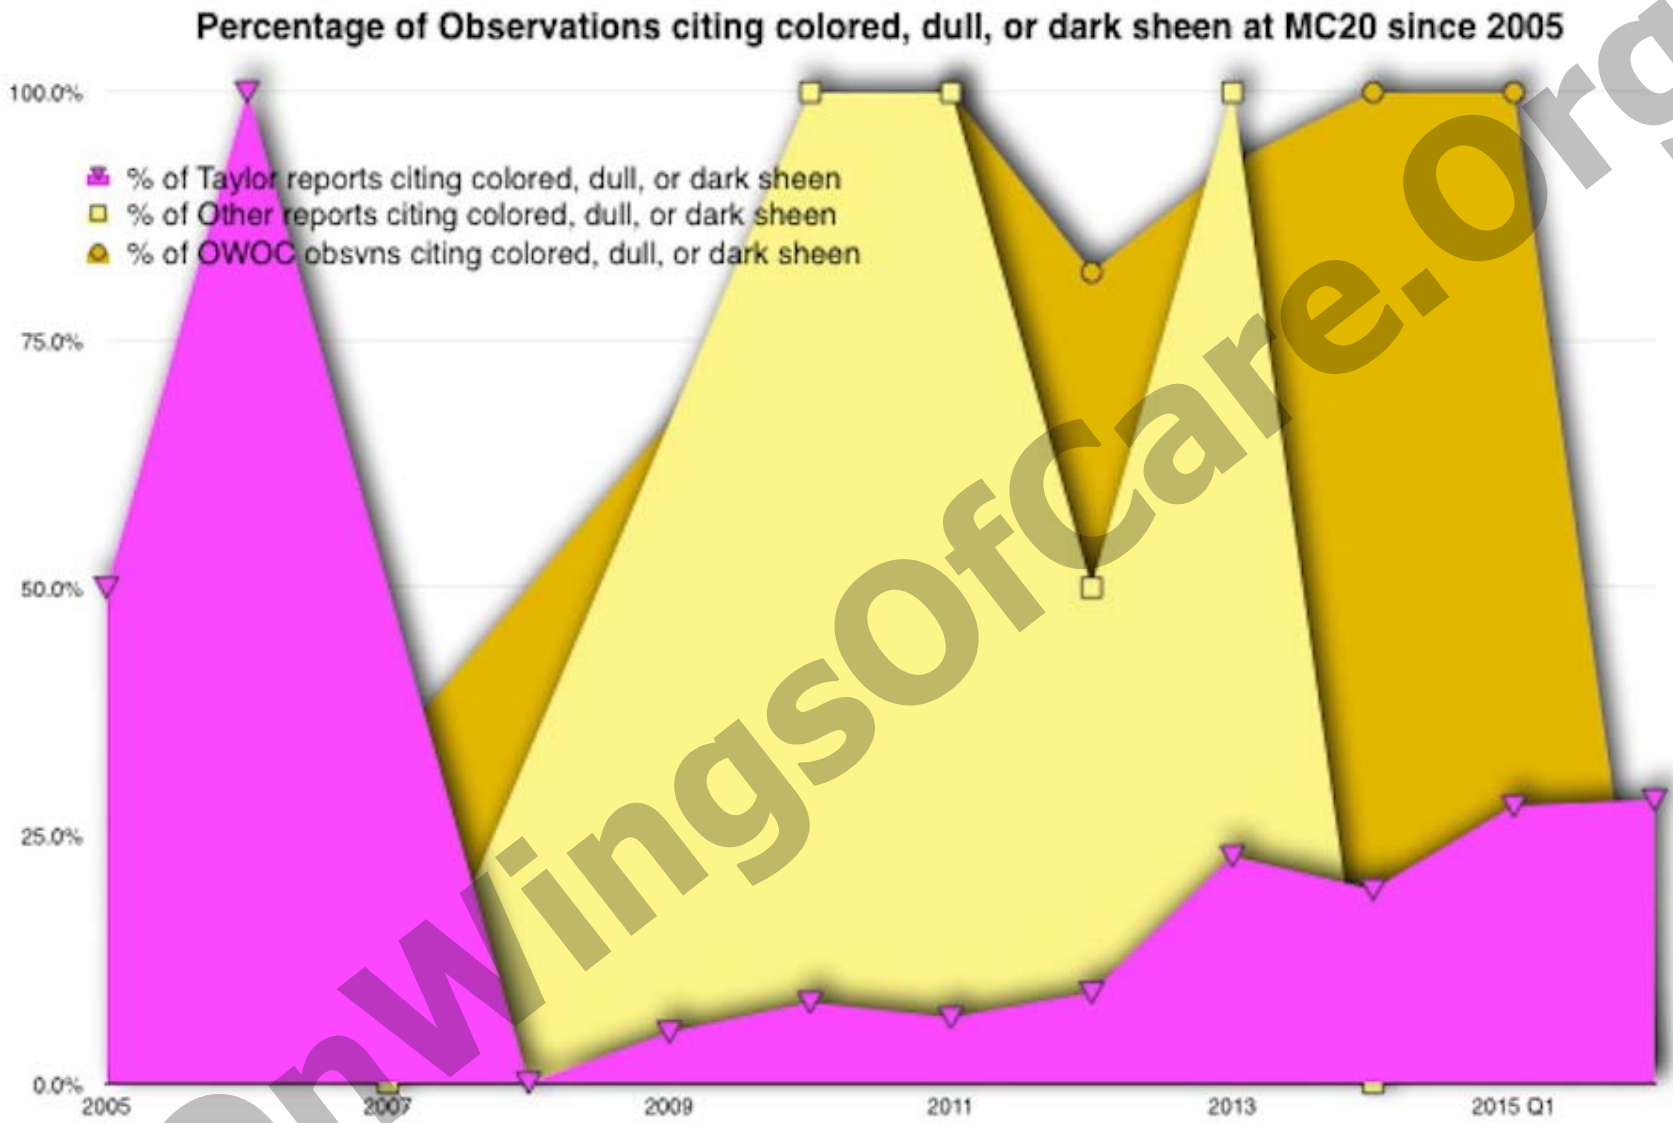
Figure 2. Percentages of all observations that noted rainbow or heavier sheen

Figure 2. Percentages of all observations that noted rainbow or heavier sheen

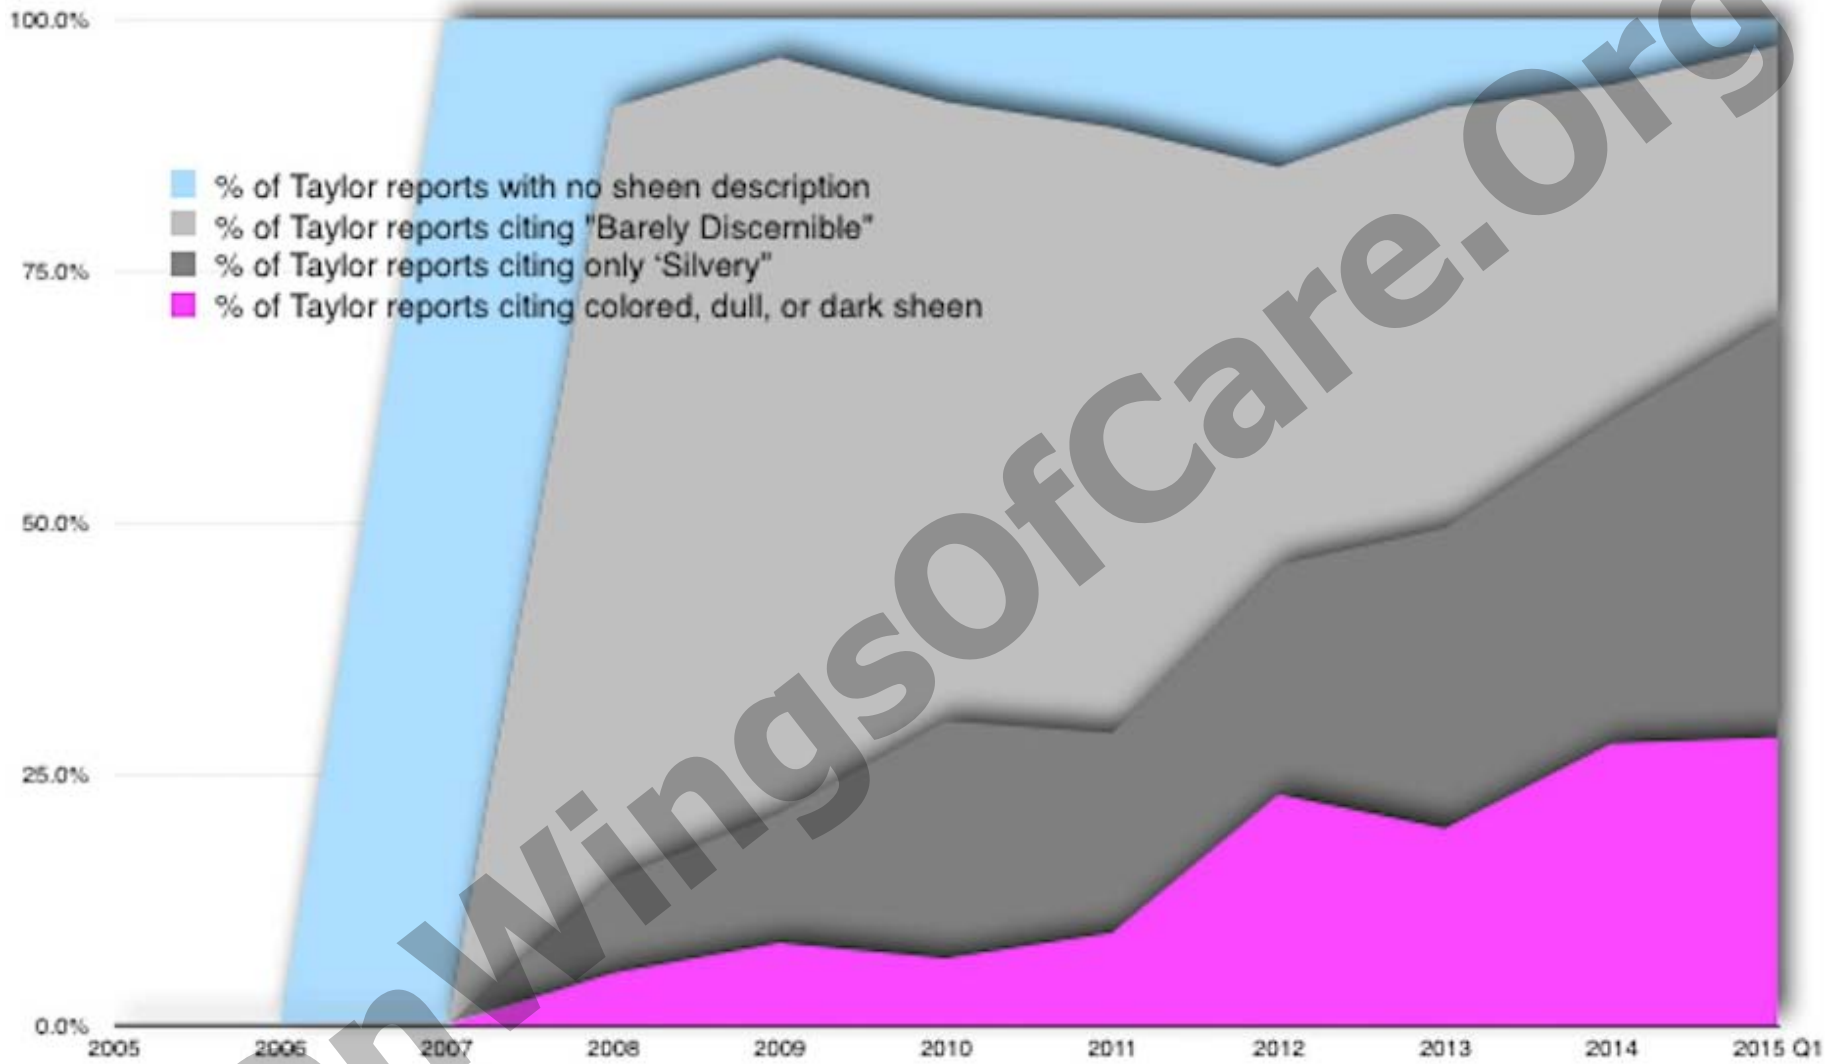
Descriptions of Sheen Appearance in MC20 from Taylor Energy since 2005

Figure 3. Descriptions of sheen color in Taylor reports of MC20

Figure 3. Descriptions of sheen color in Taylor reports of MC20

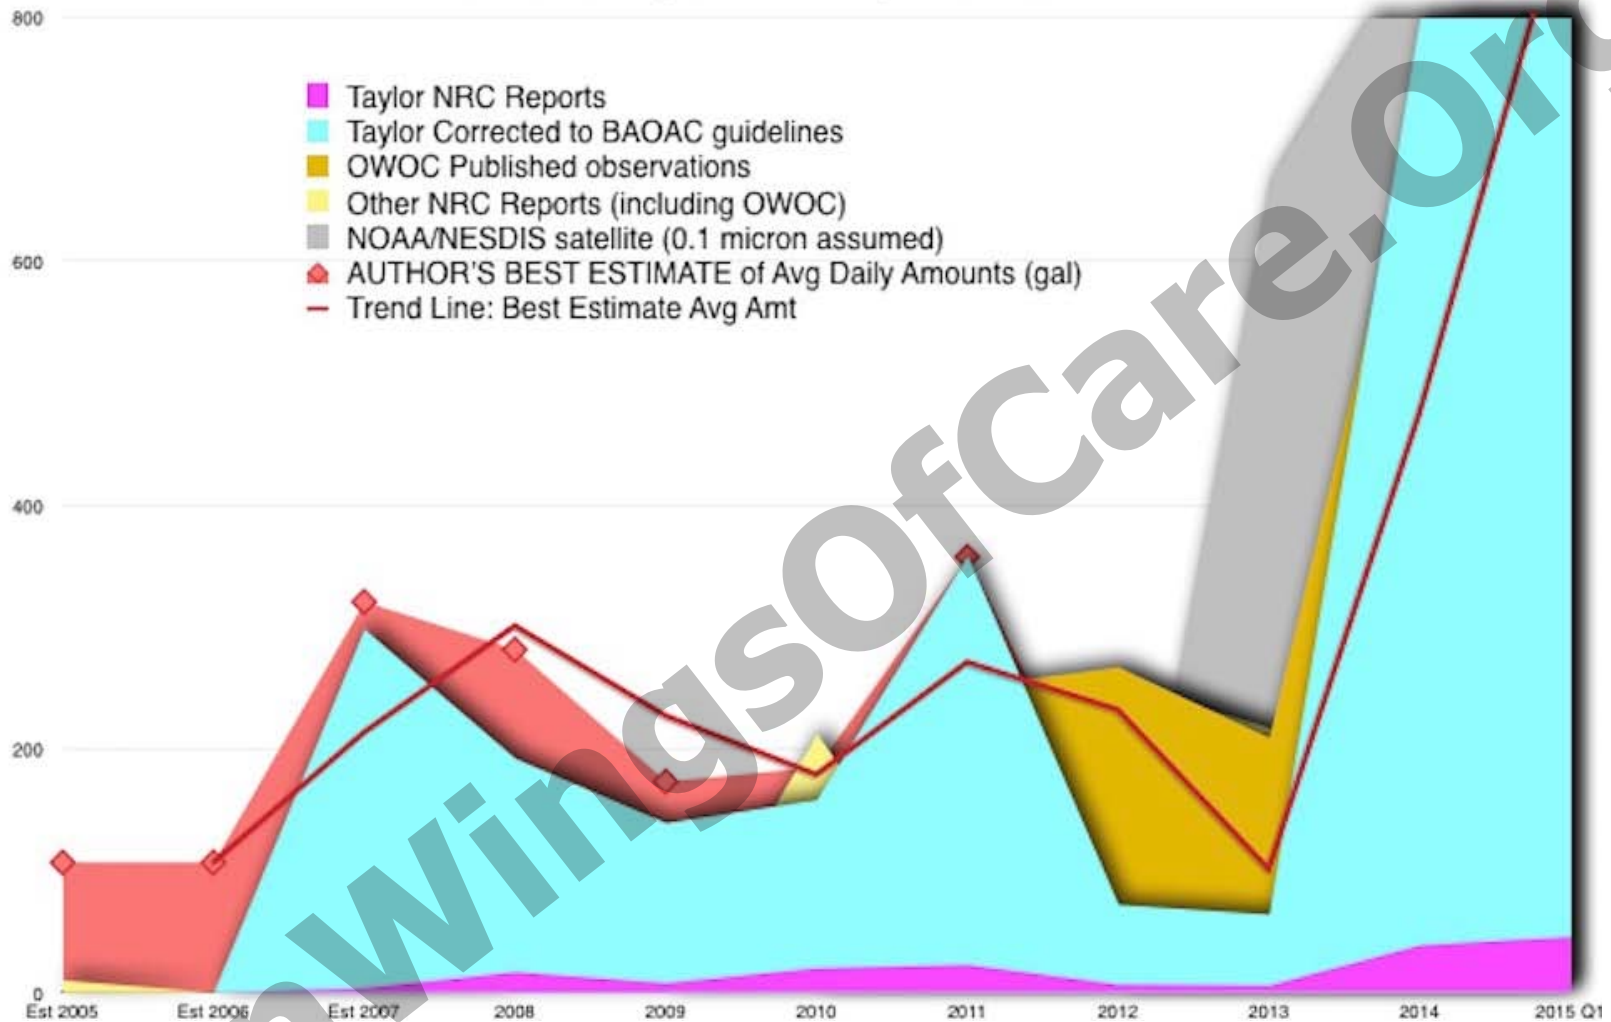
**Average Daily Amounts of Oil in Surface Sheen at MC20 since 2005 (US Gallons)  
Based on NRC reports and other published observations**

Figure 4. Average daily estimated amounts of observed oil each year since 2005

Figure 4. Average daily estimated amounts of observed oil each year since 2005

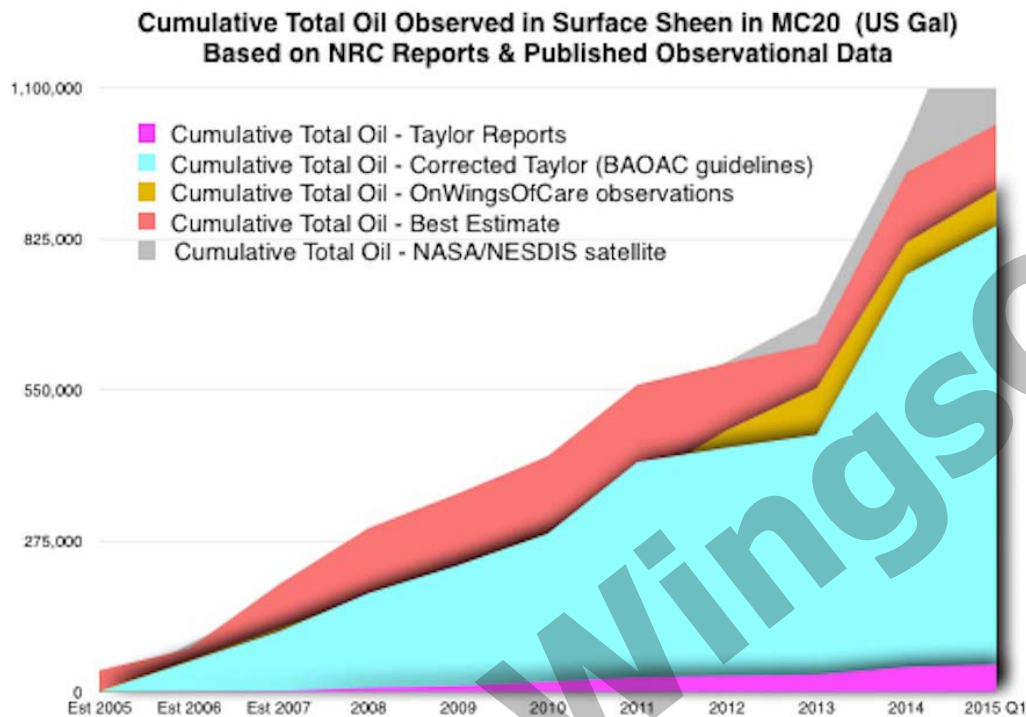
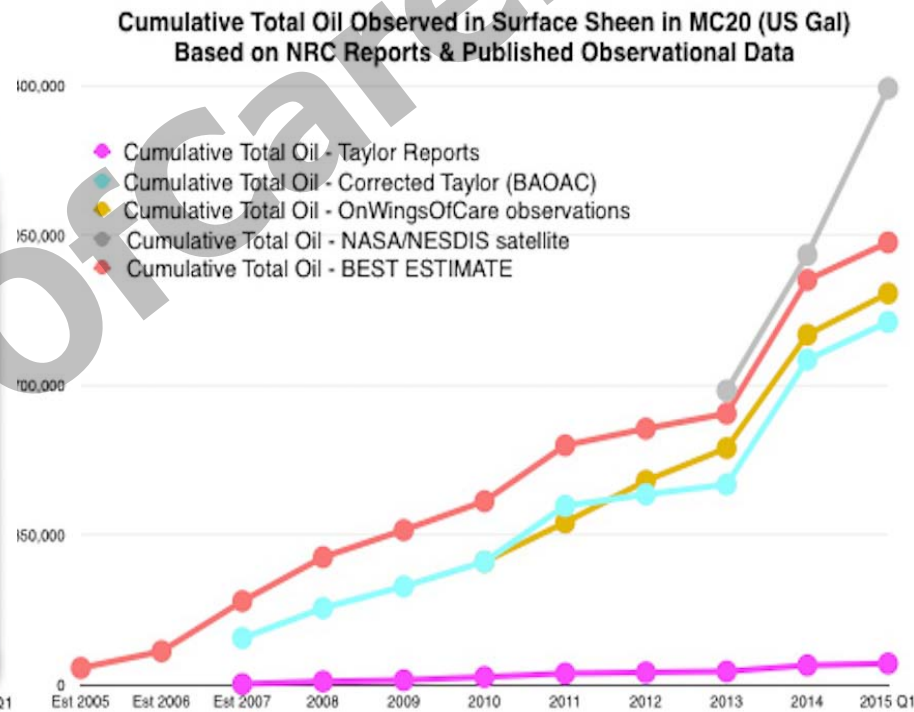
Figures 5a,b. Cumulative amount of oil observed since 2005 (or at start of observations), for all sources of reports — (a) Area Chart, (b) Line Chart.

Figure 5a. Cumulative amount of oil observed since 2005 or at start of observations, for all sources of reports — Area Chart

Figure 5b. Cumulative amount of oil observed since 2005 or at start of observations, for all sources of reports — Line Chart
